WALLS WITH HATS ON – AND MUD

THE WITCHERT WALLS OF BUCKINGHAMSHIRE

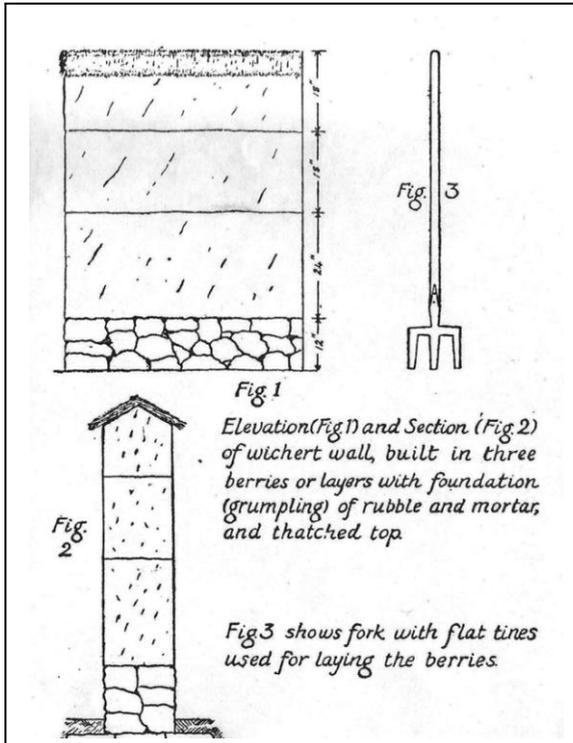
Walter Rose, a well-known Buckinghamshire craftsman and Haddenham resident, includes a brief description of witchert in his books *Good Neighbours* (1942, 34-6) and *The Village Carpenter* (1946, 101). He was the local source of information used earlier by Harman in a fuller description which was included as an Appendix to his book *Buckinghamshire Dialect* (1929). Harman also includes an informative diagram which is reproduced here (Figures 1 - 3).

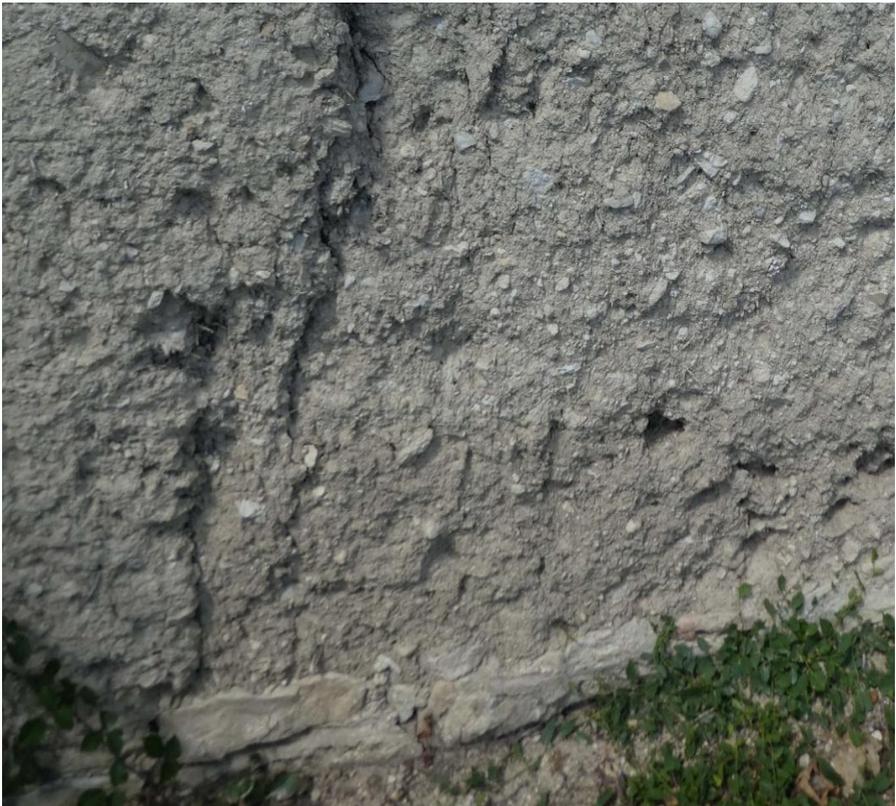
Figure 4: Fabric of witchert wall

Andrew (1986) includes a distribution map of witchert structures and notes that in Haddenham, witchert can occur only nine inches below the surface. He also notes local wisdom that a witchert wall ‘... must have a good hat and stout boots otherwise it will wet itself.’ This provides the excuse to include the accompanying photographs taken recently in Ford which clearly show ‘the boots’ and also the fabric of the wall which contains numerous bits of fragmented limestone as well as its clay matrix (Fig. 4), which are often hidden beneath render.

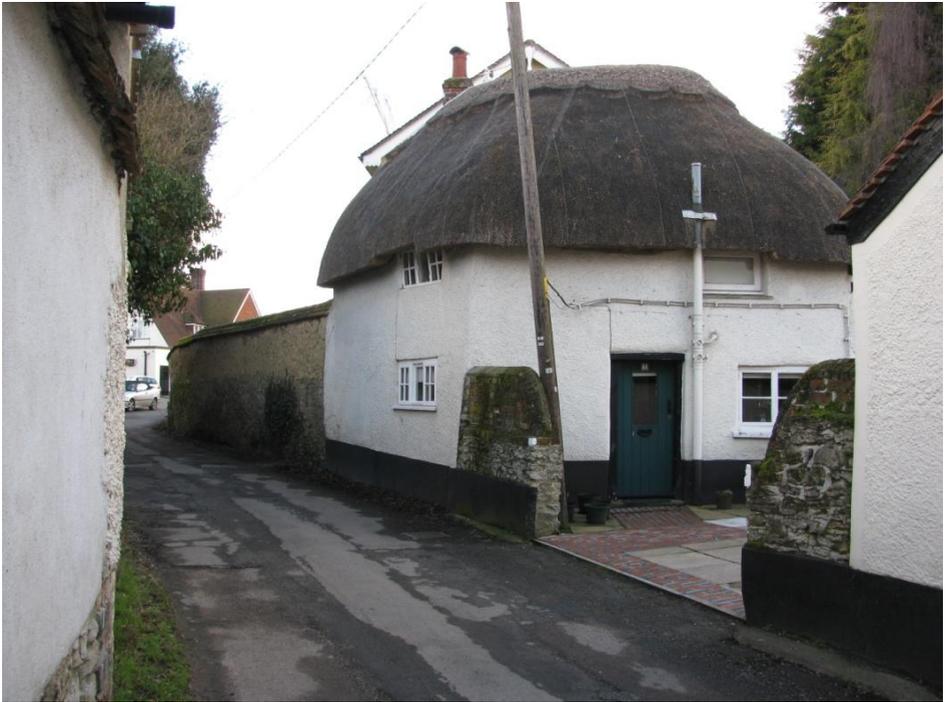
Figure 5: A well- maintained Haddenham witchert house

I couldn't resist also including a picture of a well- maintained Haddenham witchert house (Fig.5). Incidentally, one such, 'Croft Cottage', that was to be demolished was 'reconstructed' in 2007 at the Chiltern Open-Air Museum utilising witchert derived from the house itself.
